**Flood Control Project Maintenance
Levee Inspections**
LMA District Cover Sheet
Spring 2017 Levee Inspection Results

Reclamation District No. 1001 Nicolaus

Unit Cover Sheet

Spring 2017 Levee Inspection Results

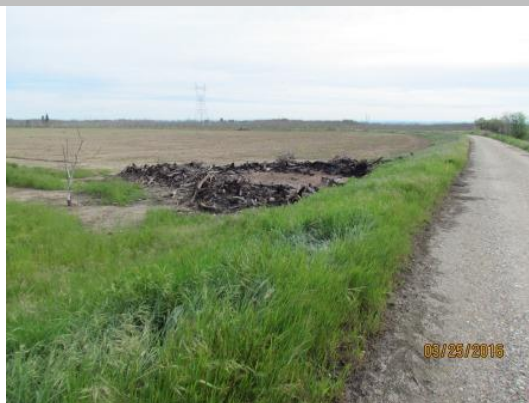
Photo 1 of 2 : SP_2017_RD1001_36_14_20170316_00010.jpg

View of pruning after burning Spring 2016.

LM Start	0.59	Rating **	M	Issue No.	14 (cont)
LM End	0.59	Issue Type +	En	Location *	LS

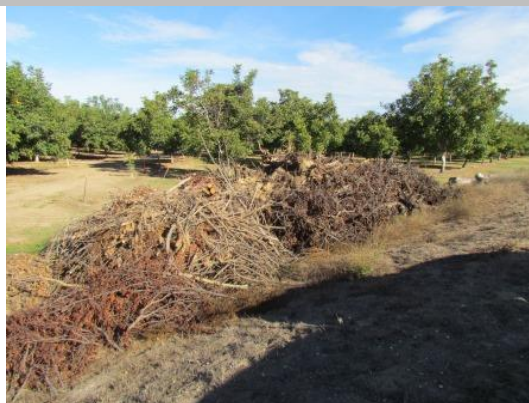
Photo 1 of 1 : SP_2017_RD1001_36_7_20170316_00005.jpg

This photo was taken from the levee crown facing east looking down the landward slope at prunings stacked up at the toe. Fall 2014.

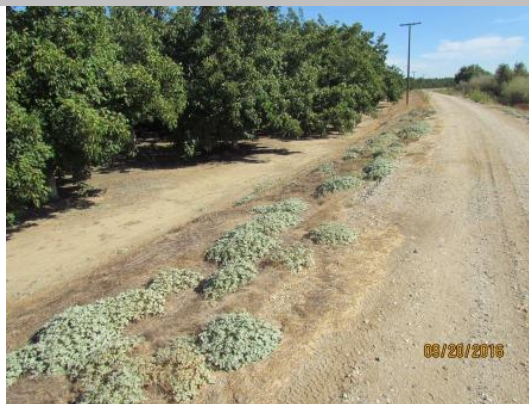
Photo 1 of 1 : SP_2017_RD1001_36_25_20170316_00019.jpg

LM Start	1.40	Rating **	M	Issue No.	25
LM End	1.40	Issue Type +	Ma	Location *	LS
Category	Earthen Levee			GPS Latitude/Longitude	
				Start	End
Item	Slope Stability			38.971589 °	38.971589 °
				-121.492049 °	-121.492049 °
DWR ID	DWR_RD1001_01_f_2016_25				
Comment Code					
S3 : Repair the levee slope damaged by vehicle traffic and prevent access where possible.					
Inspector Comment					
Slope is stable and shows no eroision, Spring 2017.

View of tier ruts on the landside levee slope looking upstream. Fall 2016.

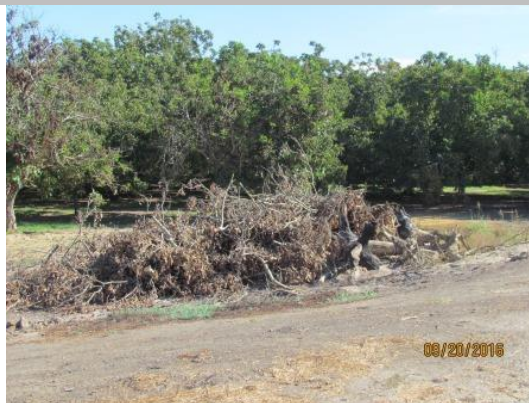
Photo 1 of 2 : SP_2017_RD1001_36_22_20170316_00017.jpg

LM Start	2.01	Rating **	A/W	Issue No.	22
LM End	2.01	Issue Type +	En	Location *	LS
Category	Earthen Levee			GPS Latitude/Longitude	
				Start	End
Item	Encroachments			38.971093 °	38.971093 °
				-121.502895 °	-121.502895 °
DWR ID	DWR_RD1001_01_f_2016_22				
Comment Code					
PR : Prunings					
Inspector Comment					
Prunings have been burned, Spring 2017.

View of pruning's on the landside toe looking upstream. Fall 2016.

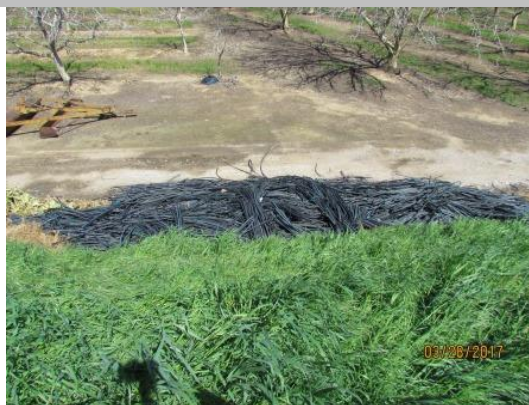
Photo 2 of 2 : SP_2017_RD1001_36_18_20170403_00023.jpg

View of irrigation pipe still piled on landside toe. Spring 2017.

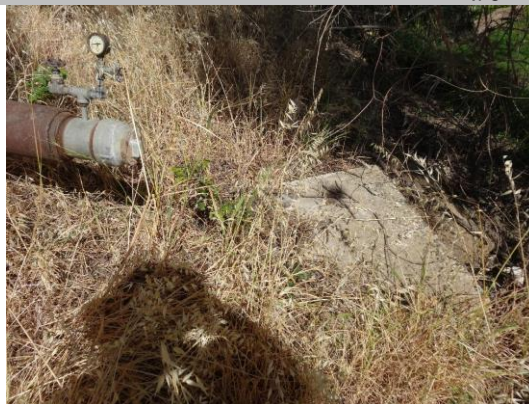
Photo 2 of 3 : UCIP_SP_2017_41673_22744.jpg

Comment Code					
Inspector Comment					
FS_ID:41673 DS_ID:22536 EP_NO: 5562 Repair Type: Non-Urgent Crossing Status: Found UCIP Comments: Pipe appears abandoned and if so should be done so properly. WS pipe plugged with stopper. Seems abandoned. Only abandoned pump base found. FIELD_STRUCT_DESC: 6-inch steel irrigation pipe through the levee, 3.5 feet below the crown, pump (removed) and pump base on the waterward berm, siphon breaker on the landward shoulder, pipe discharges into underground irrigation system on the landward side. Power pole and meter box 10 feet from the landward toe, 1-1/2-inch flexible conduit through levee, 3.5 feet below crown (Permit No. 5562, 1966) FS Date: 5/23/2013

WS- plugged pipe and pump base.

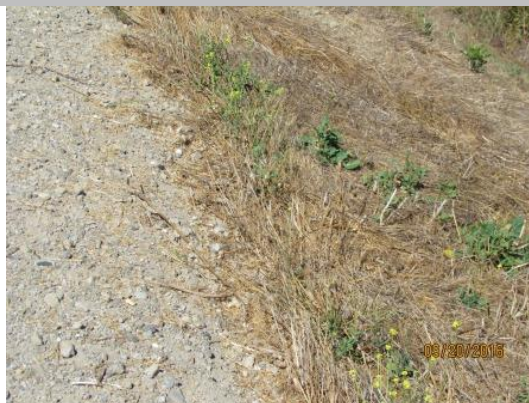
Photo 3 of 3 : SP_2017_RD1001_35_4_20170316_00003.jpg

LM Start	0.27	Rating **	A/W	Issue No.	4 (cont)	
LM End	0.27	Issue Type +	Ma	Location *	WS	
Category	Earthen Levee			GPS Latitude/Longitude		
				Start		End
Item	Animal Control			38.974323 °		38.974323 °
				-121.476442 °		-121.476442 °
DWR ID	DWR_RD1001_02_f_2014_4					
Comment Code						
A3 : No rodents visible, but rodent burrows visible; need to backfill and compact or grout burrows.						
Inspector Comment						
There is no animal activity at this location, the existing hole near the crown has been backfill & repaired by the District, Spring 2017.

Although hard to see with the grass, there is still an animal hole on waterward levee slope near the crown at this location. Hole was approximately 1' in diameter and 8" deep that needs to be repaired. There is no animal activity at this location. Fall 2016.

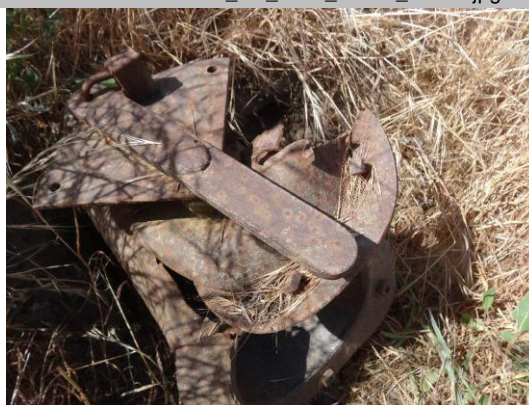
Photo 2 of 3 : UCIP_SP_2017_50740_22752.jpg

Comment Code					
Inspector Comment					
FS_ID:50740 DS_ID:22529 EP_NO: 2281 Repair Type: Non-Urgent Crossing Status: Not Found UCIP Comments: 07/13/2016 According to district president Joe Henderson, pipe was removed 2-3 years ago. No permit for removal found or evidence of pipe or its removal found. (K. Fazel - UCIP)05/23/2013:- leaky pipe end and erosion on WS.- cracked dirt mound on LS - seems not been used for some time. (P. Amatya - DWR) FIELD_STRUCT_DESC: *REMOVED* 8-inch steel irrigation pipe through the levee, 1.9 feet below the crown. Portable pump mounted on the bank during the summer months. Control valve on the waterside (WS), steel plate bolted on the WS end during the winter months. Pipe discharges into a 30-inch concrete standpipe at the landside (LS) toe. (Permit No. 2281, 1956 - Brown) [Additional Reference(s): DWR Levee Log, 1993]. FS Date: 7/13/2016

WS- seems abandoned or not been used for some time.

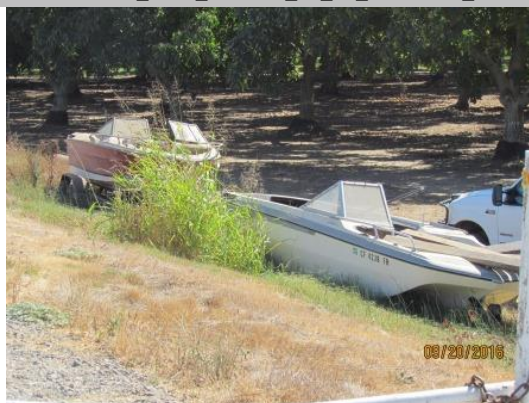
Photo 1 of 1 : SP_2017_RD1001_35_19_20170316_00011.jpg

View of two boat at the landside levee toe. Fall 2016.

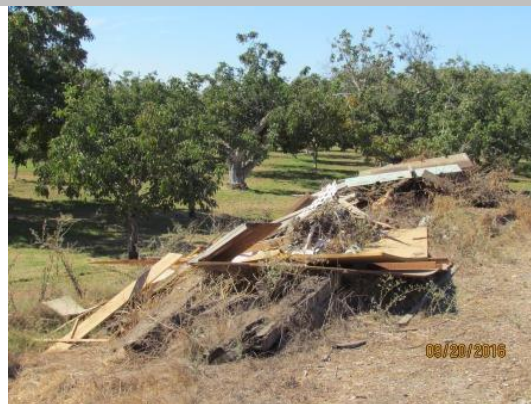
Photo 1 of 2 : SP_2017_RD1001_35_22_20170316_00013.jpg

LM Start	0.78	Rating **	A/W	Issue No.	22
LM End	0.78	Issue Type +	En	Location *	LS
Category	Earthen Levee			GPS Latitude/Longitude	
				Start	End
Item	Encroachments			38.973509 °	38.973509 °
				-121.485668 °	-121.485668 °
DWR ID	DWR_RD1001_02_f_2016_22				
Comment Code					
DE : Debris					
Inspector Comment					
Debris has been burned up, Spring 2017.

View of debris pile on the landside levee slope looking downstream. Fall 2016.

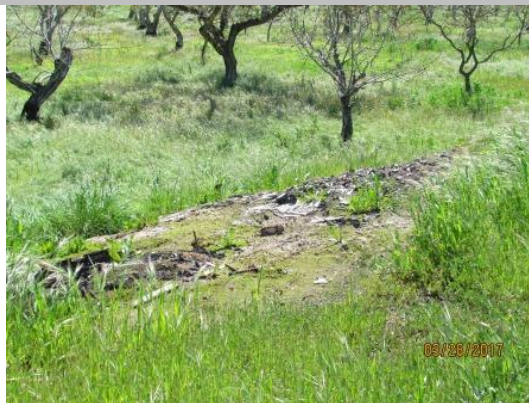
Photo 2 of 2 : SP_2017_RD1001_35_22_20170403_00026.jpg

LM Start	0.78	Rating **	A/W	Issue No.	22 (cont)	
LM End	0.78	Issue Type +	En	Location *	LS	
Category	Earthen Levee			GPS Latitude/Longitude		
				Start		End
Item	Encroachments			38.973509 °		38.973509 °
				-121.485668 °		-121.485668 °
DWR ID	DWR_RD1001_02_f_2016_22					
Comment Code						
DE : Debris						
Inspector Comment						
Debris has been burned up, Spring 2017.

View of debris that has been burned, Spring 2017.

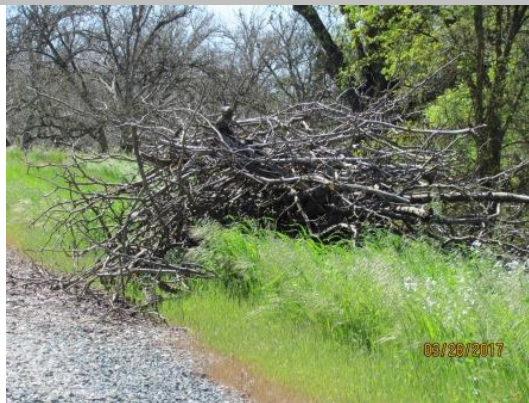
Photo 1 of 1 : SP_2017_RD1001_35_15_20170403_00030.jpg

View looking downstream of pruning's on levee hinge point, Spring 2017.

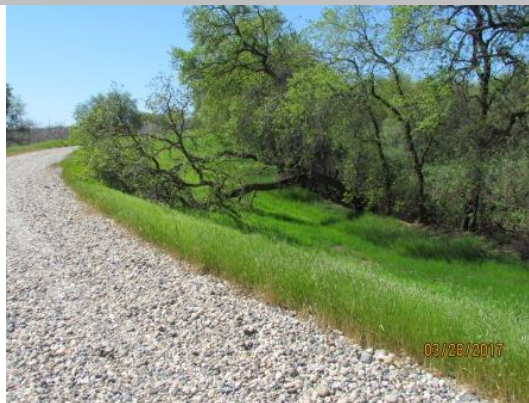
Photo 1 of 1 : SP_2017_RD1001_35_25_20170403_00033.jpg

View looking downstream of a tree that has fallen last rainy season and needs to be removed from slope, Spring 2017.

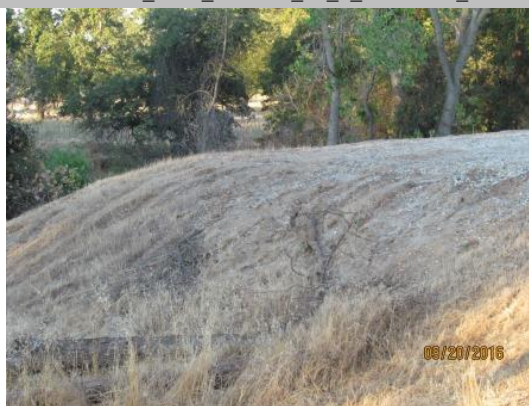
Photo 2 of 2 : SP_2017_RD1001_37_2_20170316_00003.jpg

View of the same rutting on the landside of the levee facing downstream. Fall 2016.

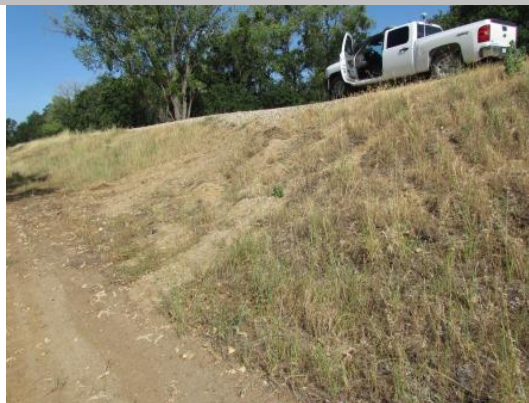
Photo 1 of 1 : SP_2017_RD1001_37_23_20170316_00016.jpg

View of the rutting on the landside of the levee from the toe facing downstream.

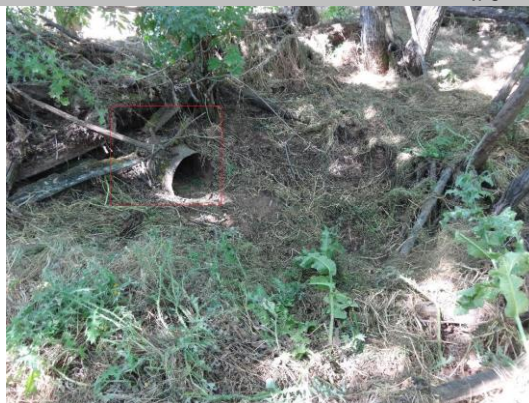
Photo 1 of 3 : UCIP_SP_2017_14128_23308.jpg

WS- abandoned CMP on berm of the levee.

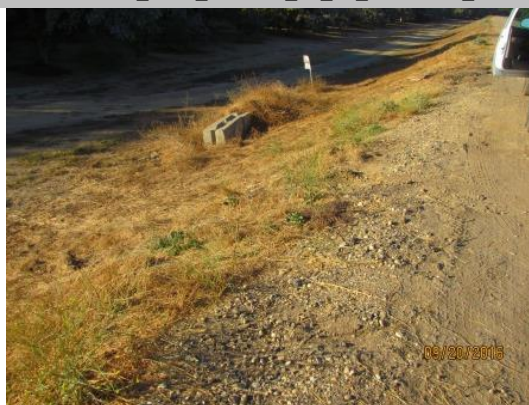
Photo 1 of 1 : SP_2017_RD1001_37_29_20170316_00019.jpg

Continual damage caused by vehicles going around the gate. Fall 2016

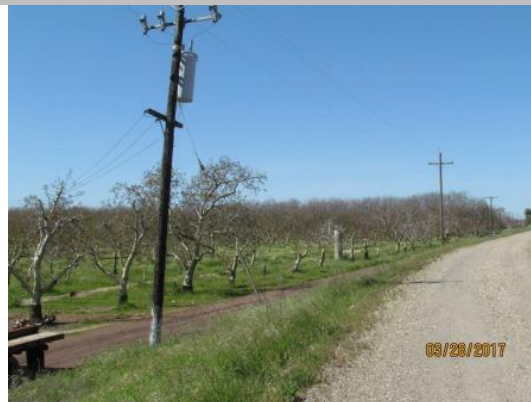
Photo 1 of 1 : SP_2017_RD1001_37_20_20170403_00047.jpg

View looking downstream of unpermitted pole, Spring 2017.

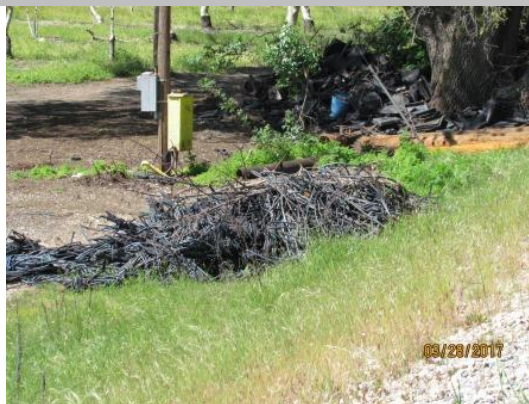
Photo 1 of 1 : SP_2017_RD1001_37_26_20170403_00048.jpg

View of drip irrigation and trash on levee slope. Spring 2017.

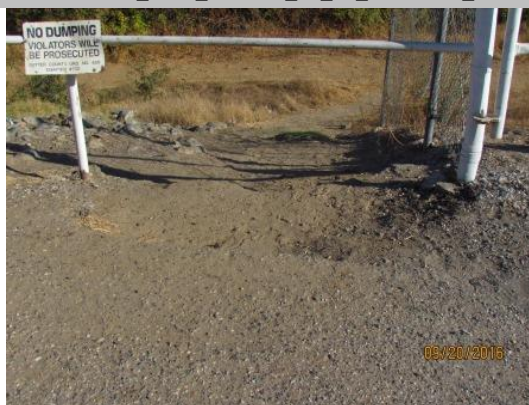
Photo 1 of 1 : SP_2017_RD1001_37_40_20170316_00029.jpg

View of slope instability on the waterside at gate caused by foot traffic. Fall 2016.

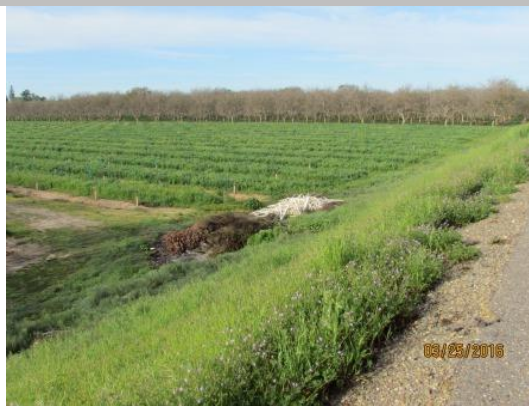
Photo 1 of 1 : SP_2017_RD1001_37_45_20170316_00031.jpg

PVC pipe and debris at landside toe.

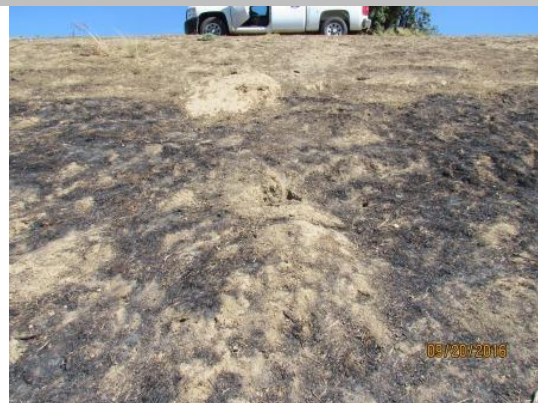
Photo 1 of 1 : SP_2017_RD1001_37_48_20170316_00033.jpg

View of existing rodent hole that are no longer active on the landside slope. Fall 2016.

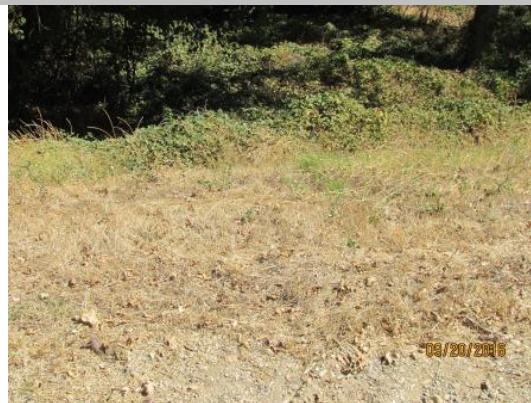
Photo 1 of 1 : SP_2017_RD1001_38_46_20170316_00027.jpg

View of blackberry bush starting to climb the landside levee slope. Fall 2016.

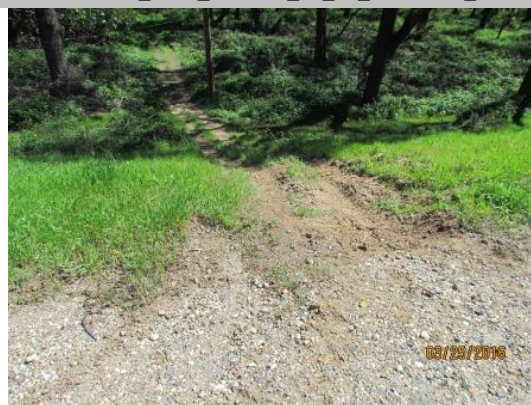
Photo 1 of 1 : SP_2017_RD1001_38_63_20170316_00036.jpg

Landside slope erosion caused by vehicles.

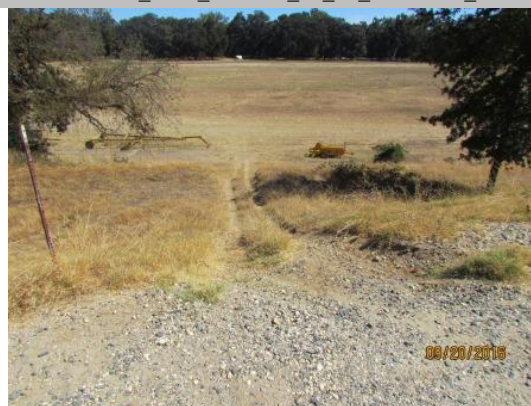
Photo 1 of 1 : SP_2017_RD1001_38_16_20170316_00009.jpg

View of rut made up the landside levee slope. Fall 2016.

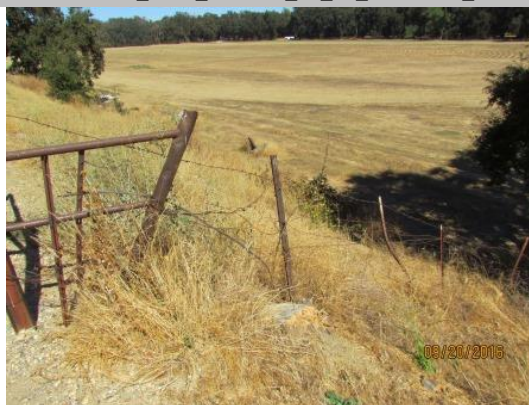
Photo 1 of 1 : SP_2017_RD1001_38_61_20170316_00035.jpg

View of tree stump, landside crown at gate. Fall 2016.

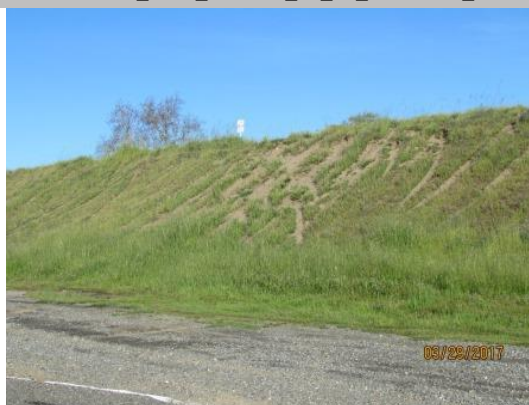
Photo 1 of 1 : SP_2017_RD1001_38_51_20170403_00078.jpg

View of continual vehicles driving up levee slope, should be monitored and maintained, Spring 2017.

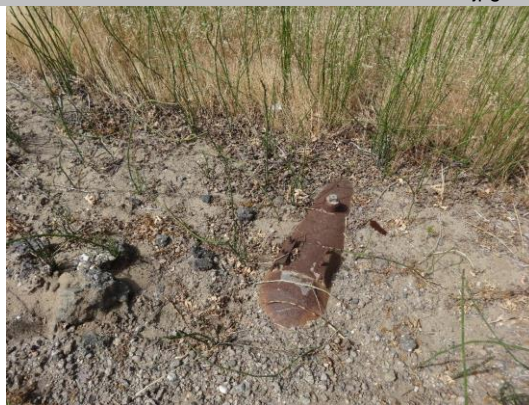
Photo 2 of 3 : UCIP_SP_2017_14627_24133.jpg

WS- exposed pipe on levee slope.

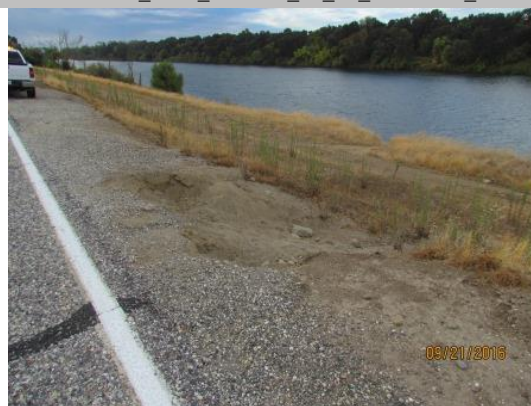
Photo 1 of 2 : SP_2017_RD1001_38_54_20170316_00030.jpg

View of vehicle ruts in levee shoulder on the waterside looking downstream. Fall 2016.

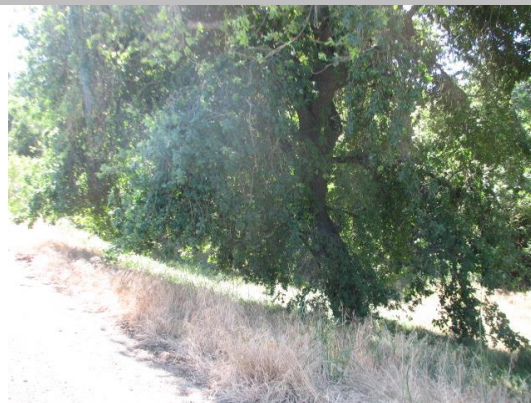
Photo 1 of 1 : SP_2017_RD1001_38_151_20170316_00046.jpg

Trees need to be trimmed up at least 5 feet. Spring 2013

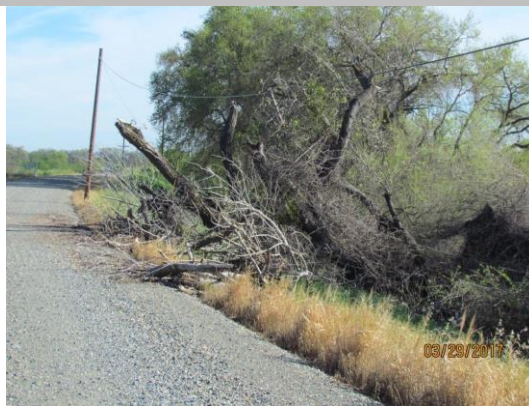
Photo 1 of 1 : SP_2017_RD1001_39_11_20170403_00018.jpg

View looking upstream of fallen tree in waterside slope, Spring 2017.

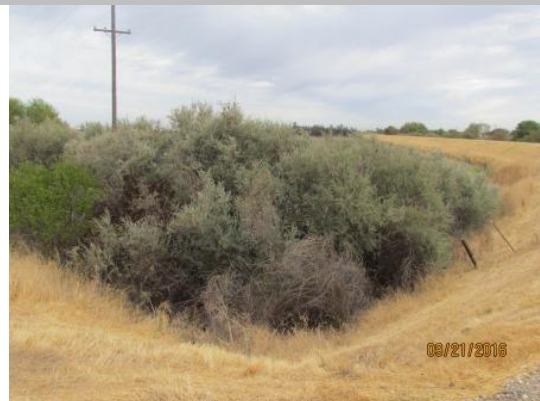
Photo 1 of 2 : SP_2017_RD1001_40_18_20170316_00004.jpg

View of trees that need to be trimmed for visibility on the landside looking upstream. Fall 2016.

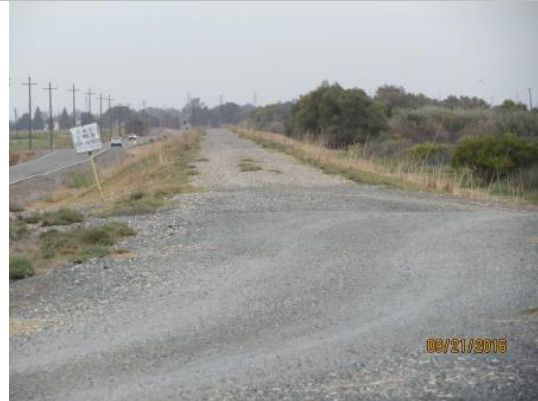
Photo 1 of 1 : SP_2017_RD1001_40_8_20170316_00003.jpg

View of crown where there is cross traffic looking upstream. Monitor this area and fix as needed.

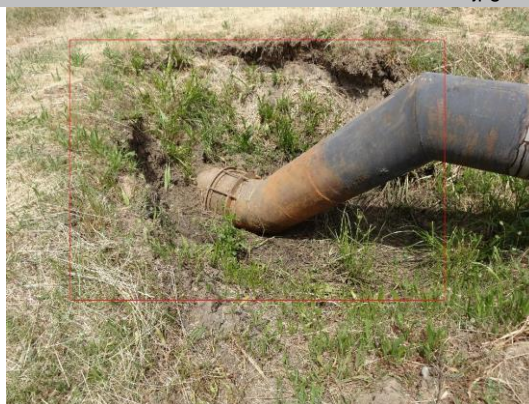
Photo 3 of 3 : UCIP_SP_2017_50692_23426.jpg

WS- large depression on levee berm at pipe daylight

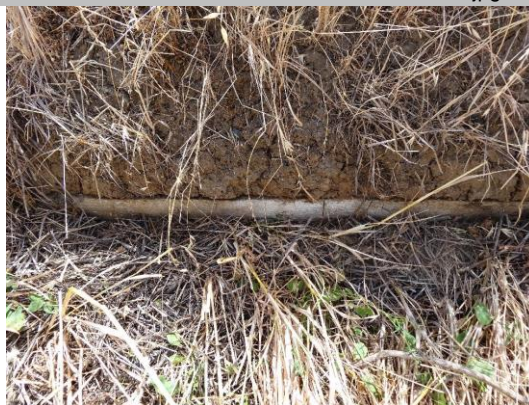
Photo 2 of 2 : UCIP_SP_2017_13509_22085.jpg

LS- almost buried concrete headwall. Only upper portion of the wall is visible.

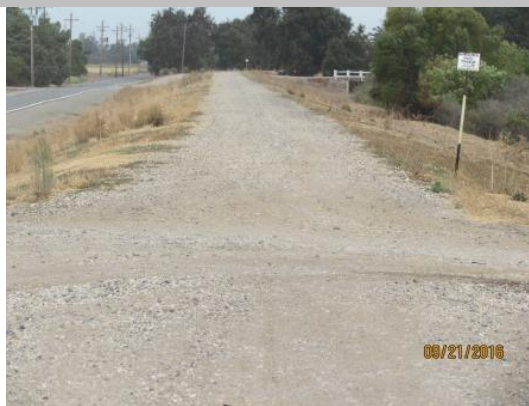
Photo 1 of 1 : SP_2017_RD1001_40_7_20170316_00002.jpg

View of crown where there is cross traffic looking upstream. Monitor this area and fix as needed.

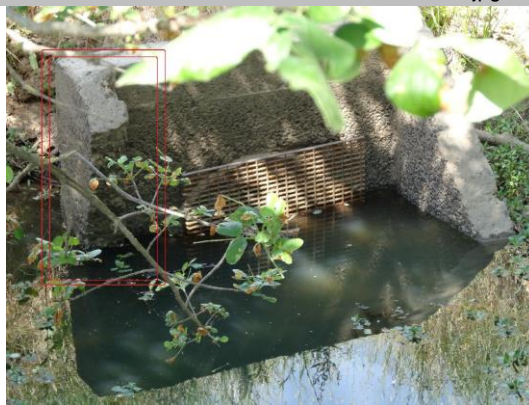
Photo 3 of 3 : UCIP_SP_2017_41724_22032.jpg

WS- inlet pipe with trashrack in a damaged wing wall
